# **Attachment B:**

# **Photographs**

# I. Photographs of features identified and discussed in the report

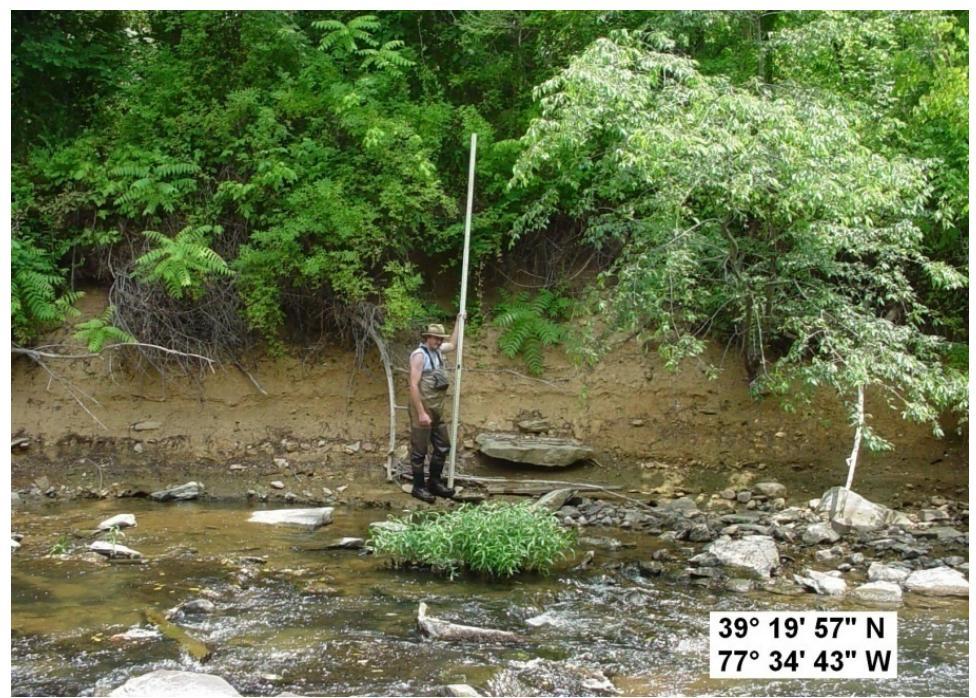
Photo 70: Left bank height (11') between MD 464 Bridge and existing bridge abutment. This vertical bank is composed of legacy sediments and is typical of the banks found throughout the site.

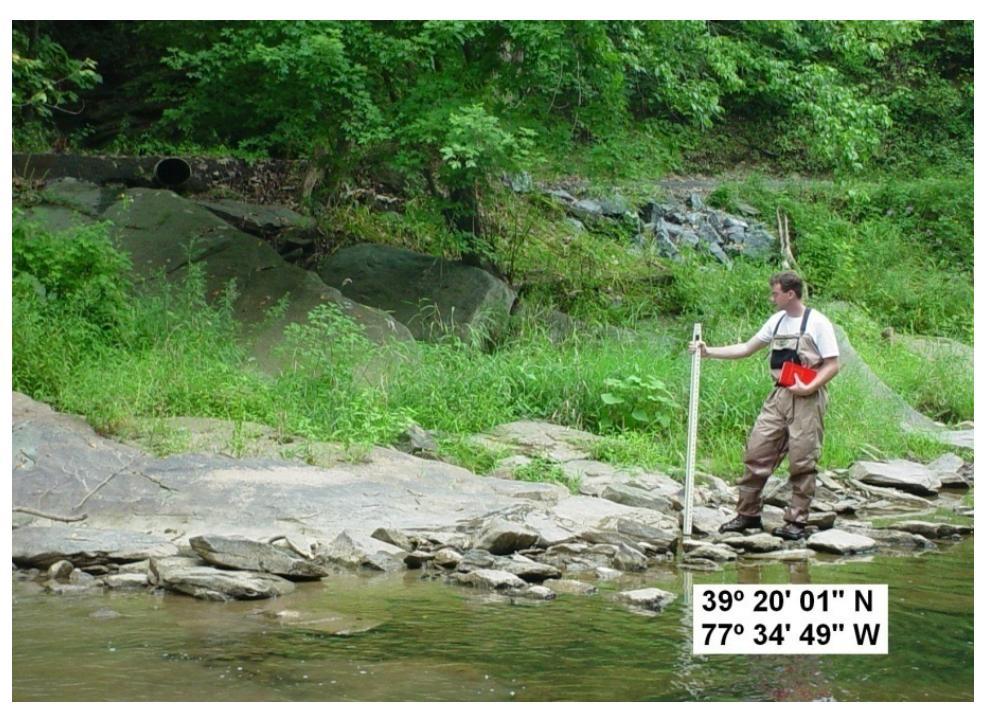
Photo 109: Bedrock outcrop on west (right) bank directing flows to the left.

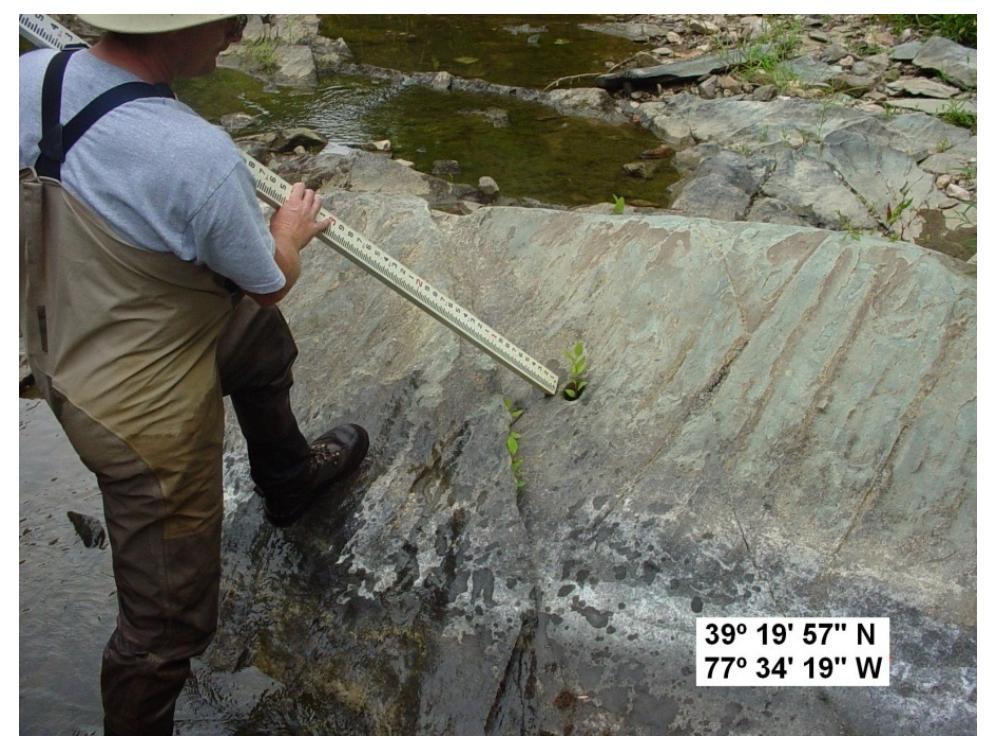
Photo 37: Bedrock with bore hole indicating blasting activity in this region of Catoctin Creek.

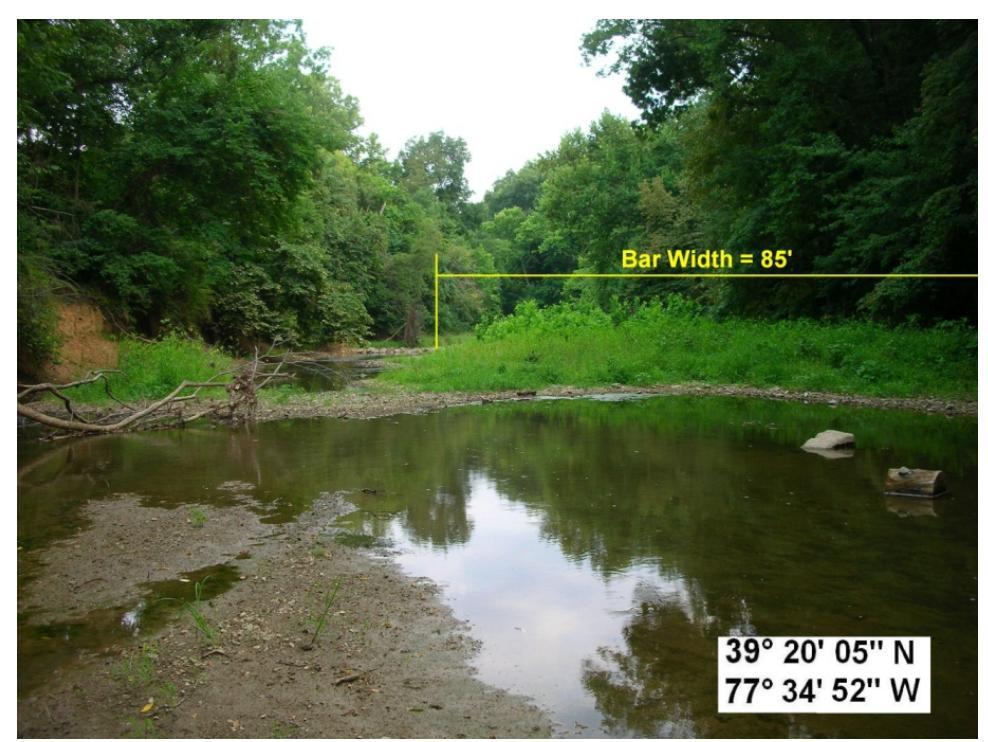
Photo 121: High bank, low depositional features.

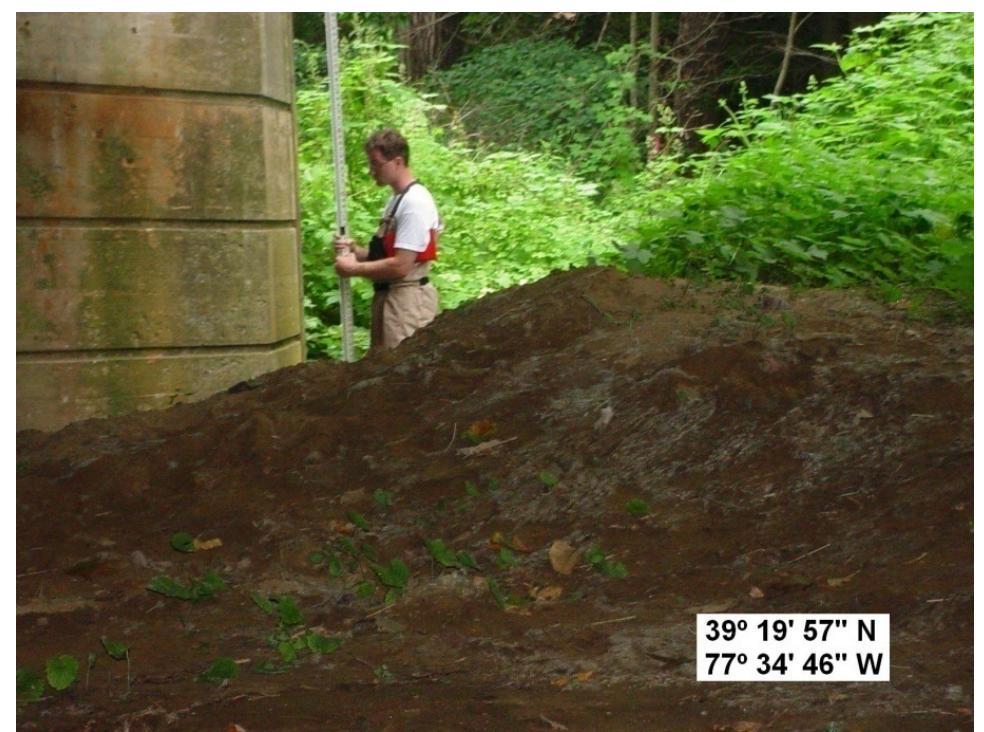
Photo 83: Scour at Pier B and deposition in the B-C span.

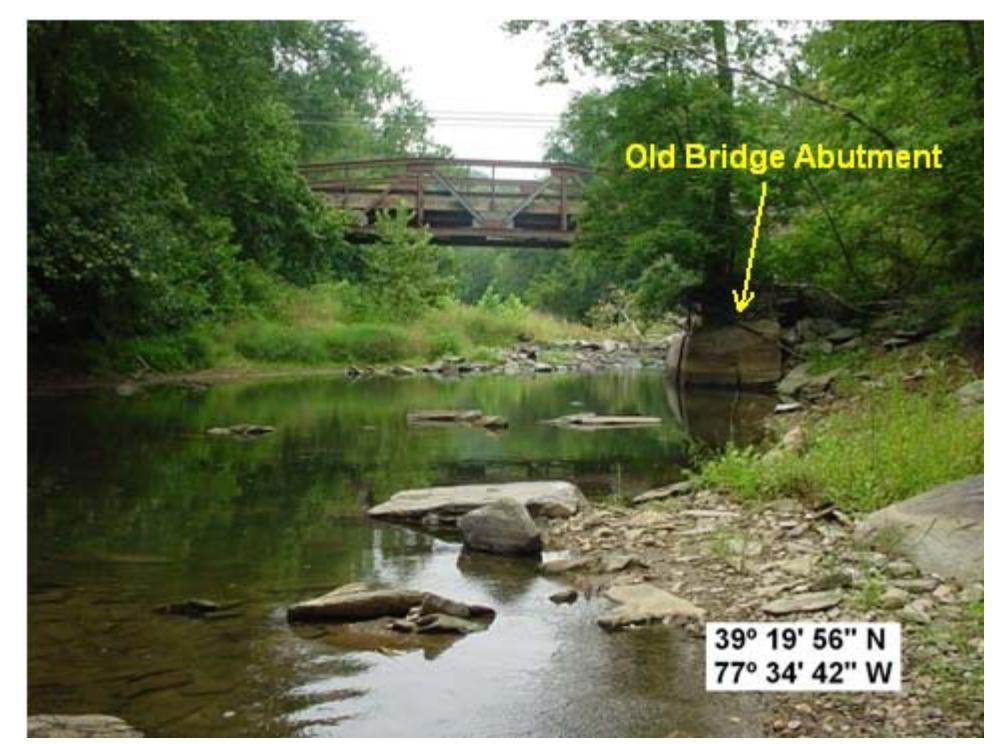
Photo 67: Looking upstream, old bridge abutment (with 5.5' deep scour hole) on right receiving majority of flow redirected by MD 464 Pier D

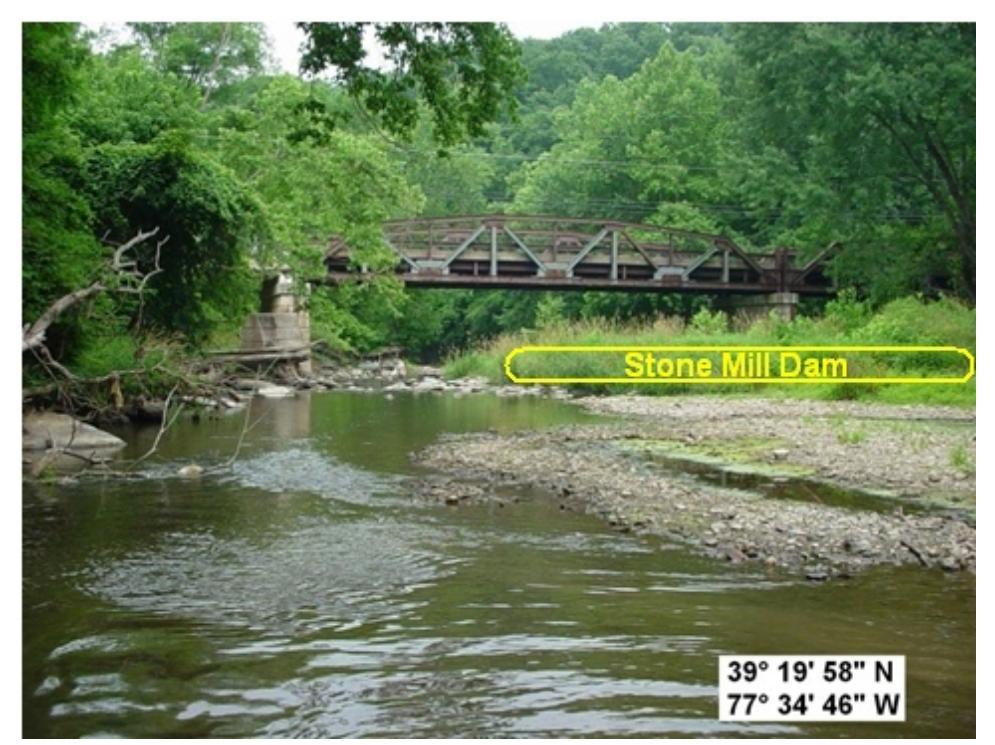
Photo 101: Approach flows constricted by 6' high stone mill dam on right (in vegetation) and high banks with debris jam on left.

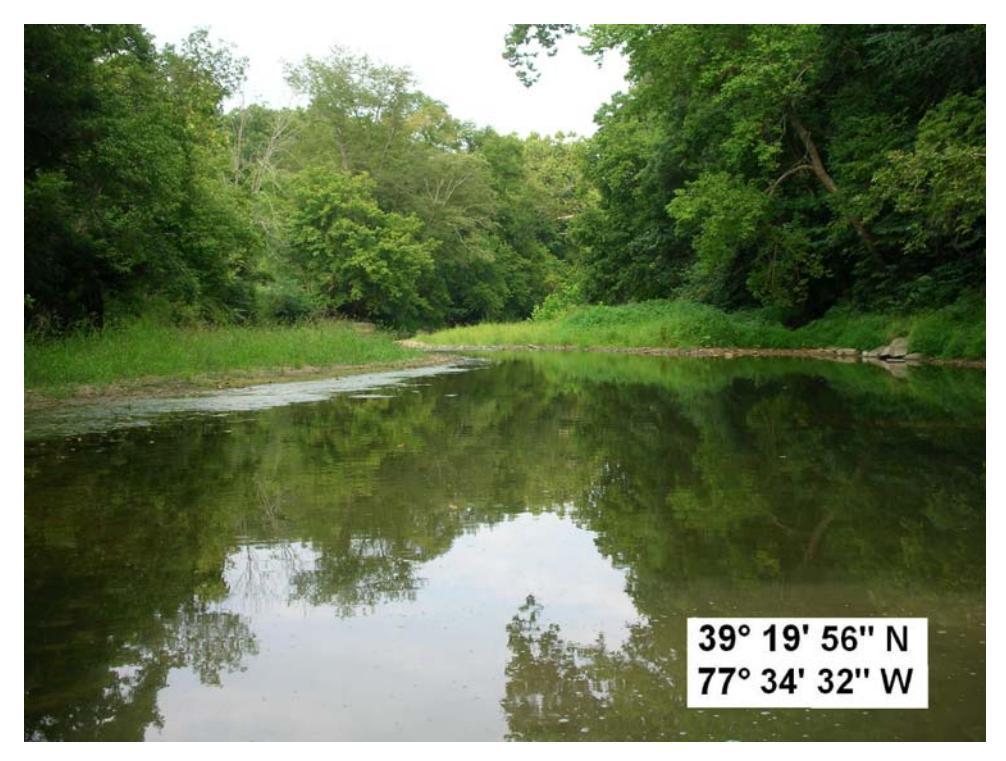
Photo 59: Channel movement, low depositional feature.

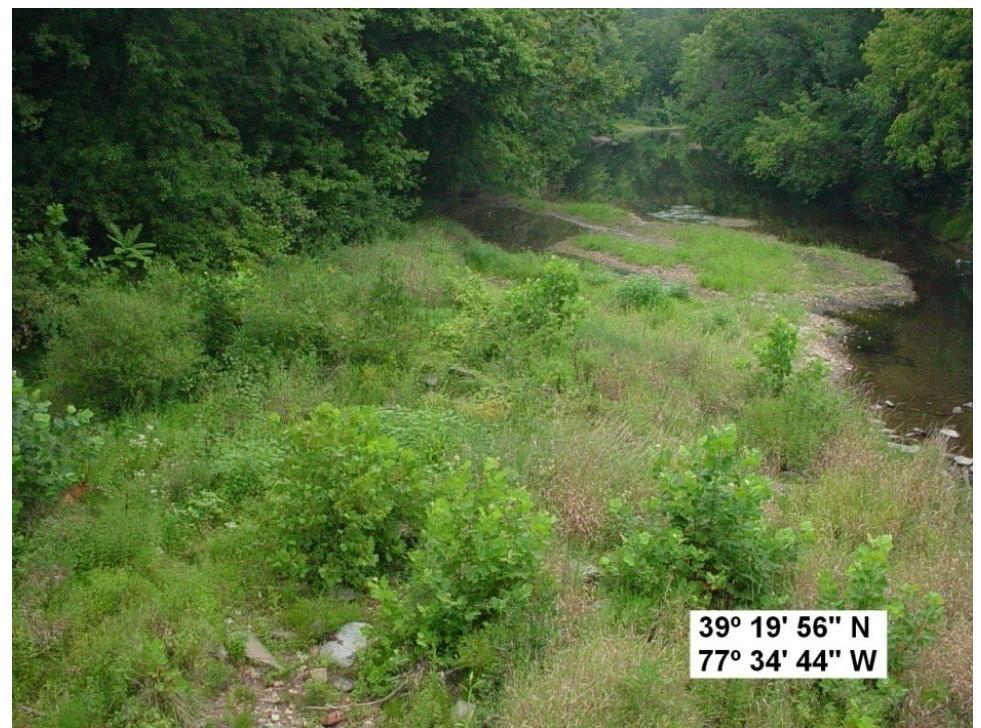
Photo 133: Top of B-C span looking upstream. Mill dam is in vegetation.

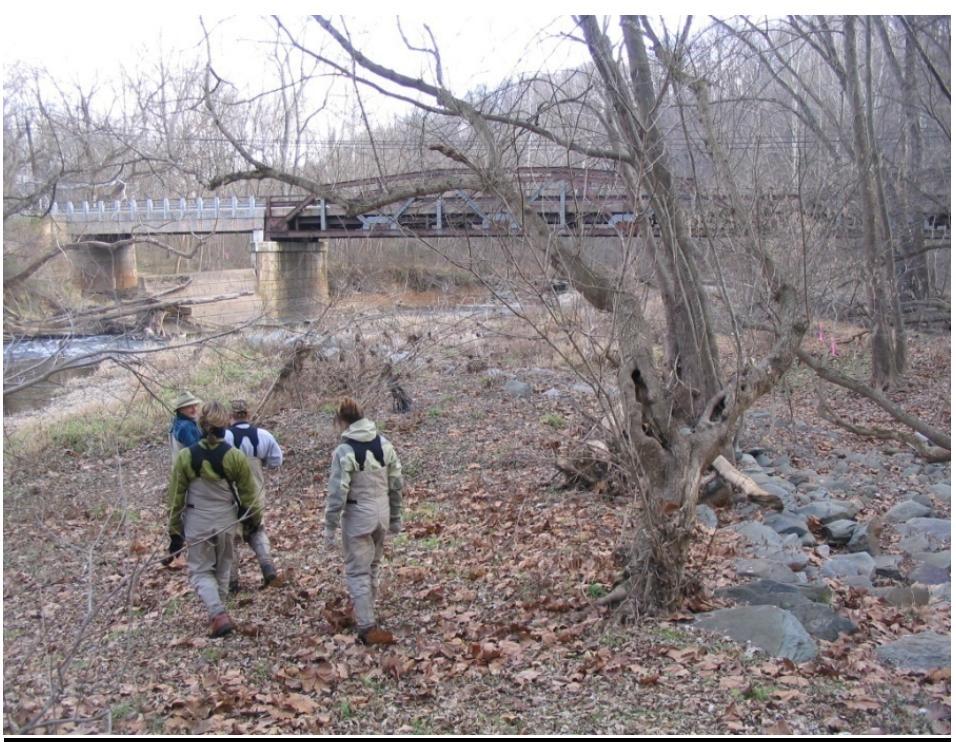
Photo 96: Stone mill dam extending from right bank to wall at Pier D.

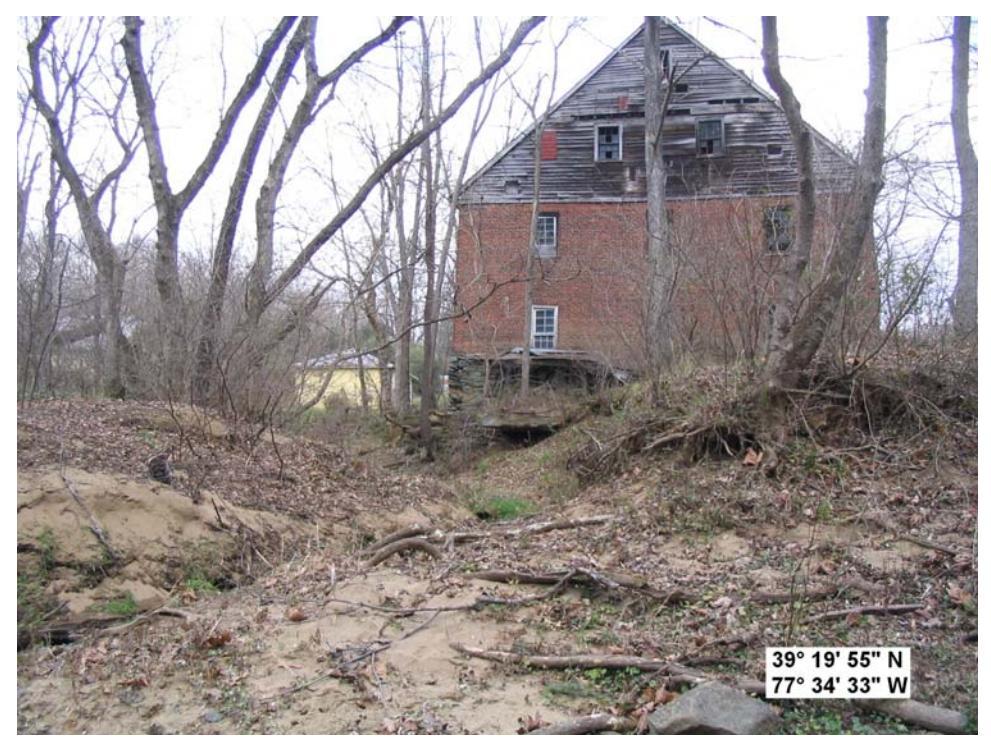
Photo 56: Mill building and tailrace.

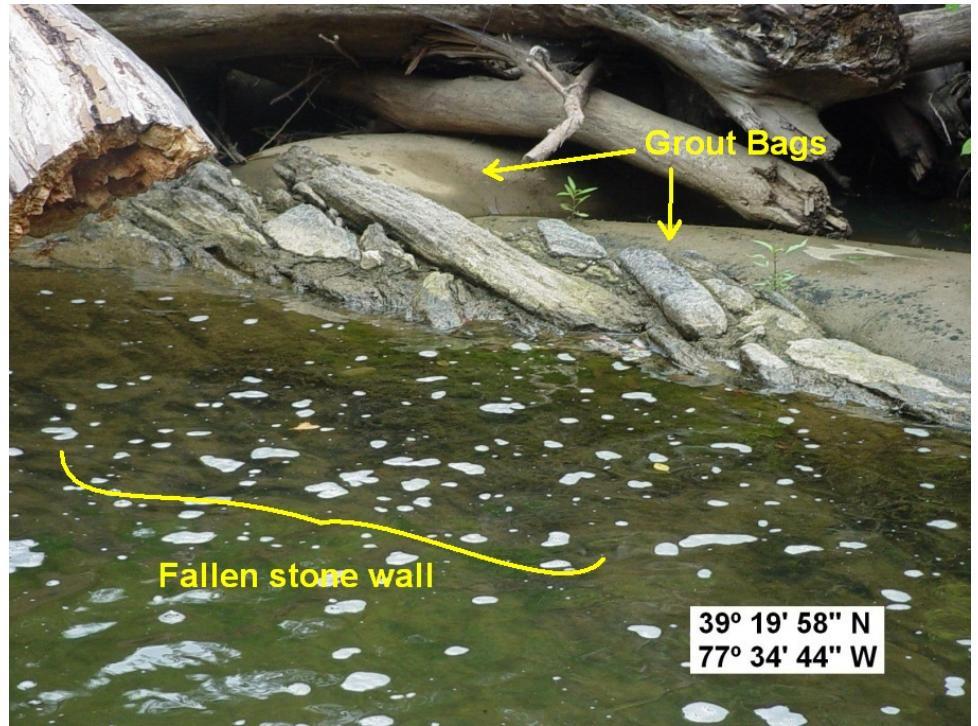
Photo 91: Broken stone wall and grout bags at upstream wall of Pier D.

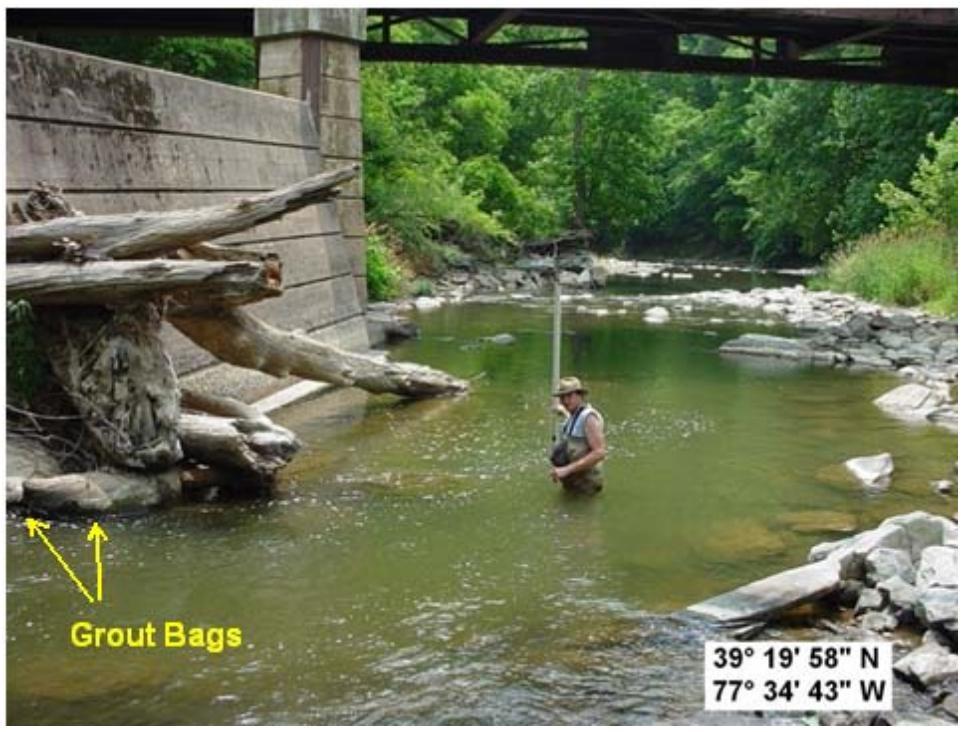
Photo 89: Scour hole (4.5' deep) and grout bags (left) at Pier D.

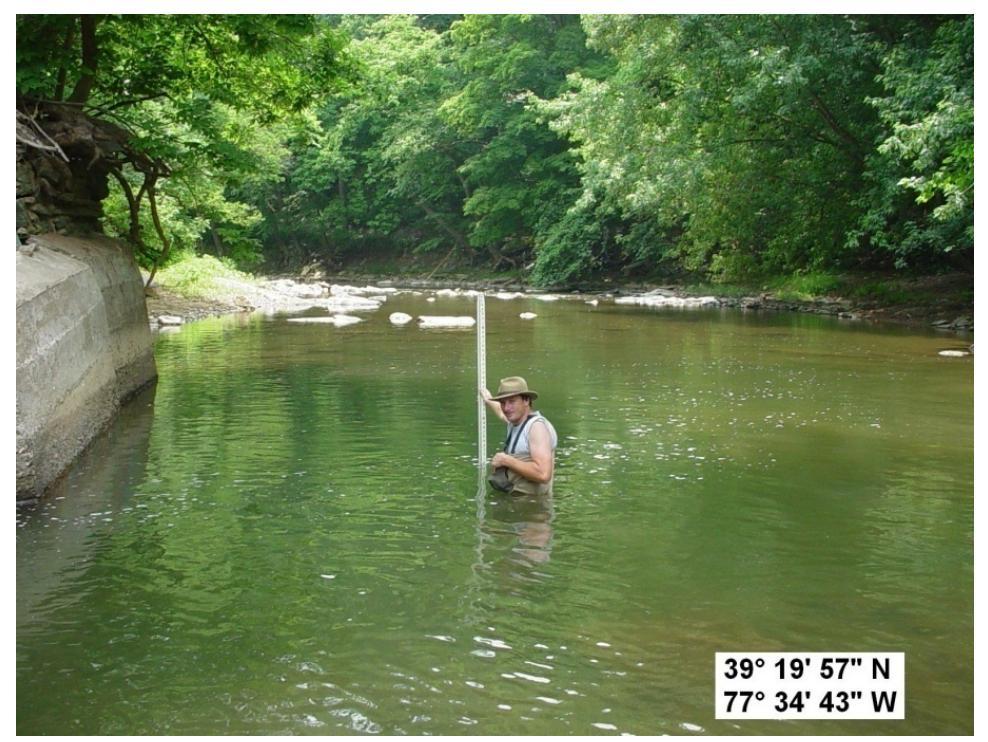
Photo 69: Scour hole (>5.5' deep) at old bridge abutment.

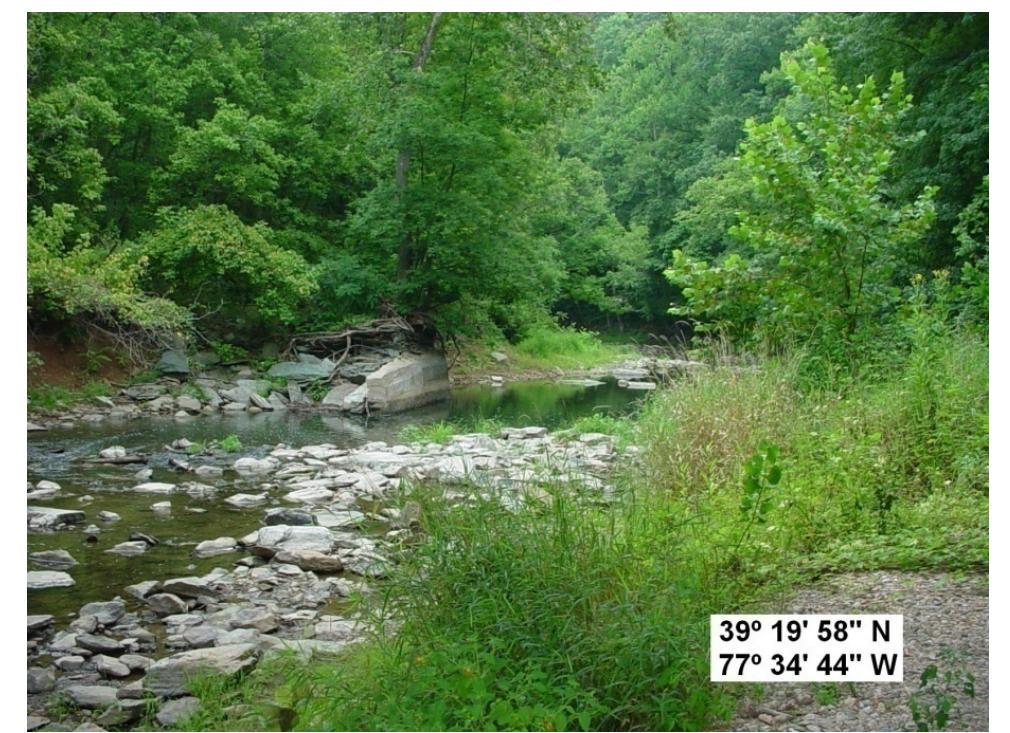
Photo 85: Looking downstream from center of C-D span.

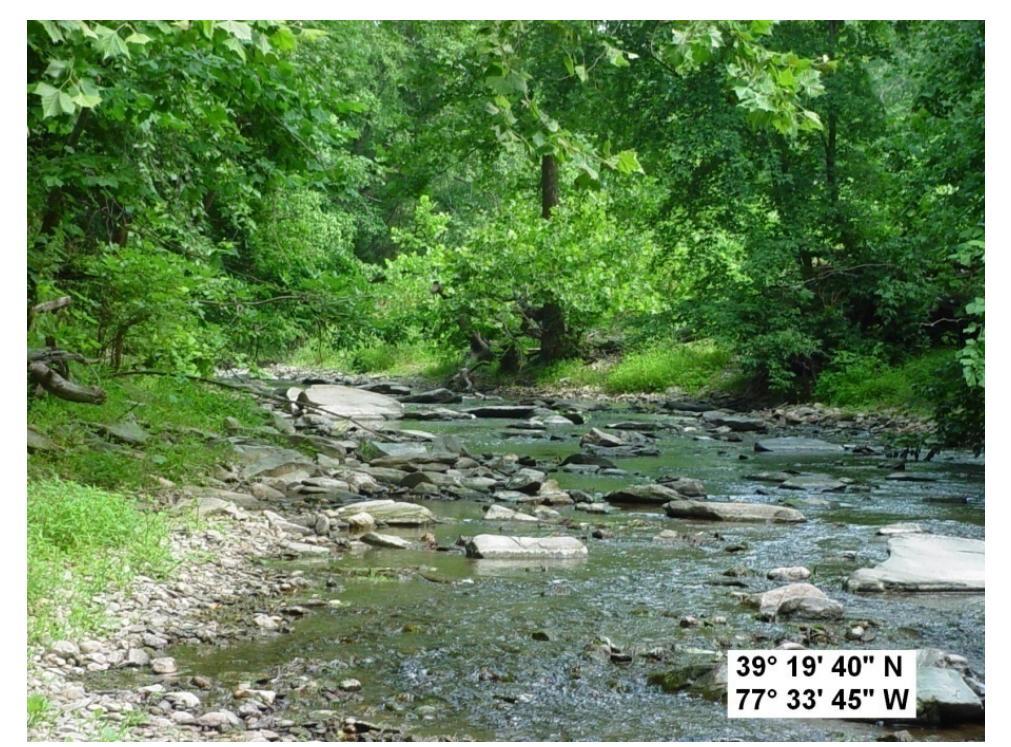
Photo 4: Degraded local base level point downstream of MD 464 Bridge.

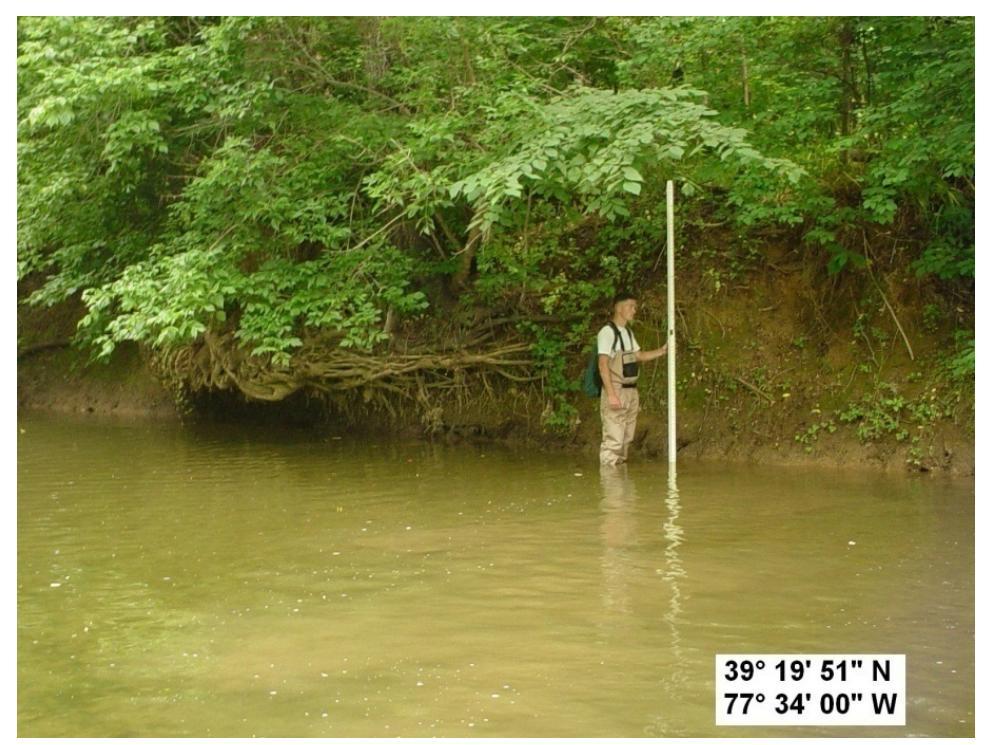
Photo 12: High vertical banks (9') consisting of laminated sediments.

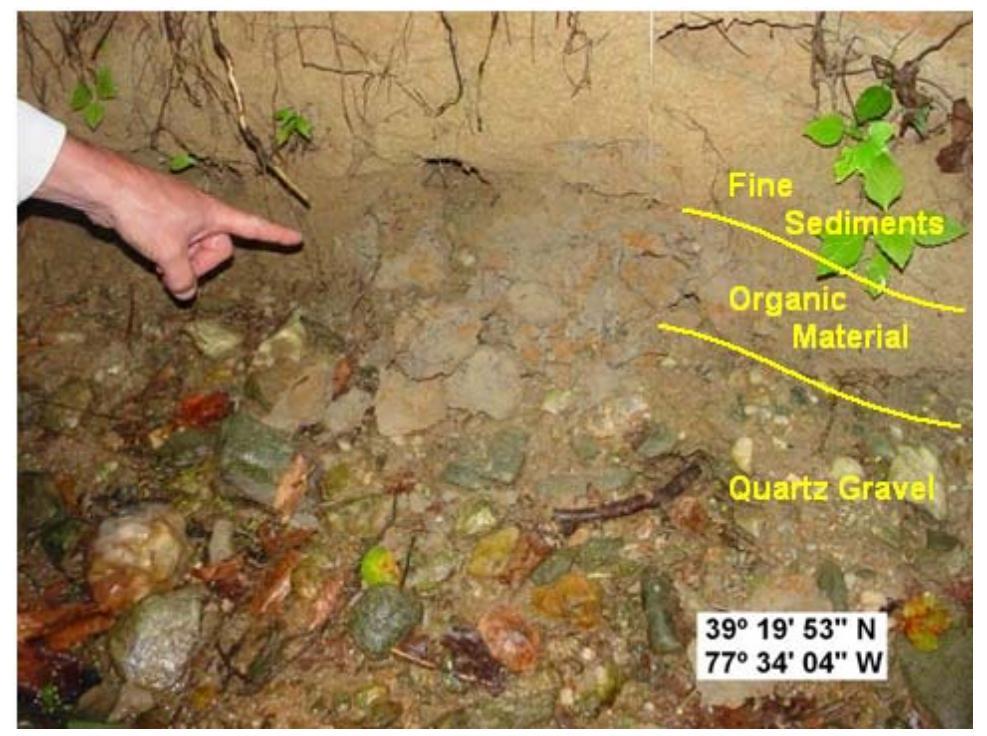
Photo 22: Layers of fine laminated sediments (top), grey/blackish organic material (middle) and quartz gravel (bottom).

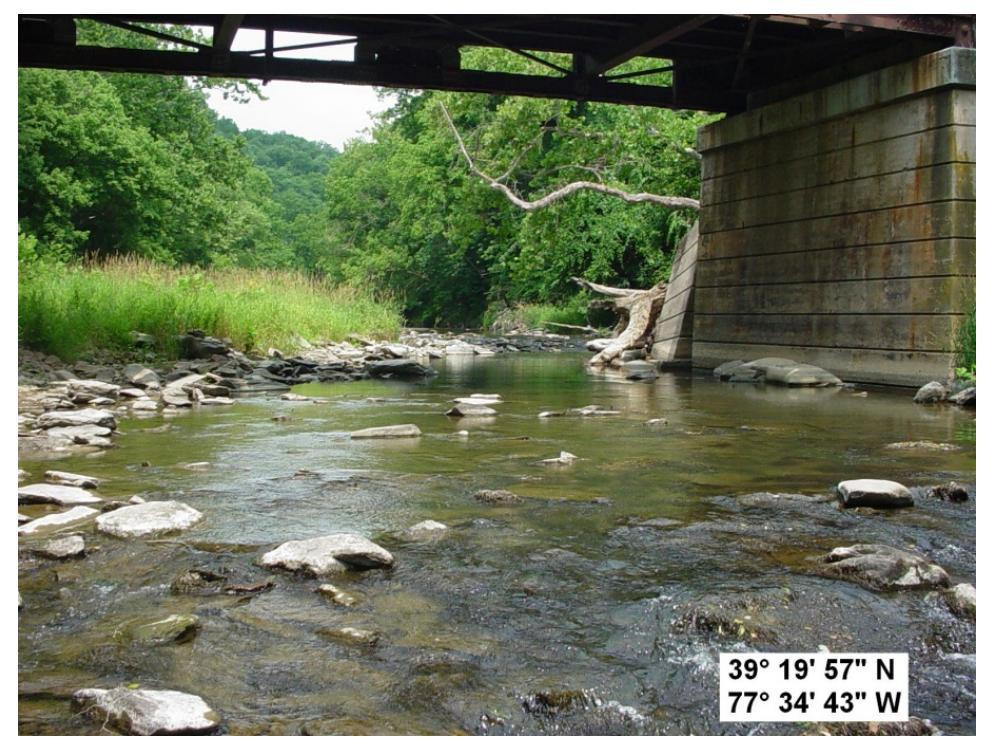
Photo 74: Remnants of stone mill dam compose substrate for LFHG feature at MD 464 Bridge.

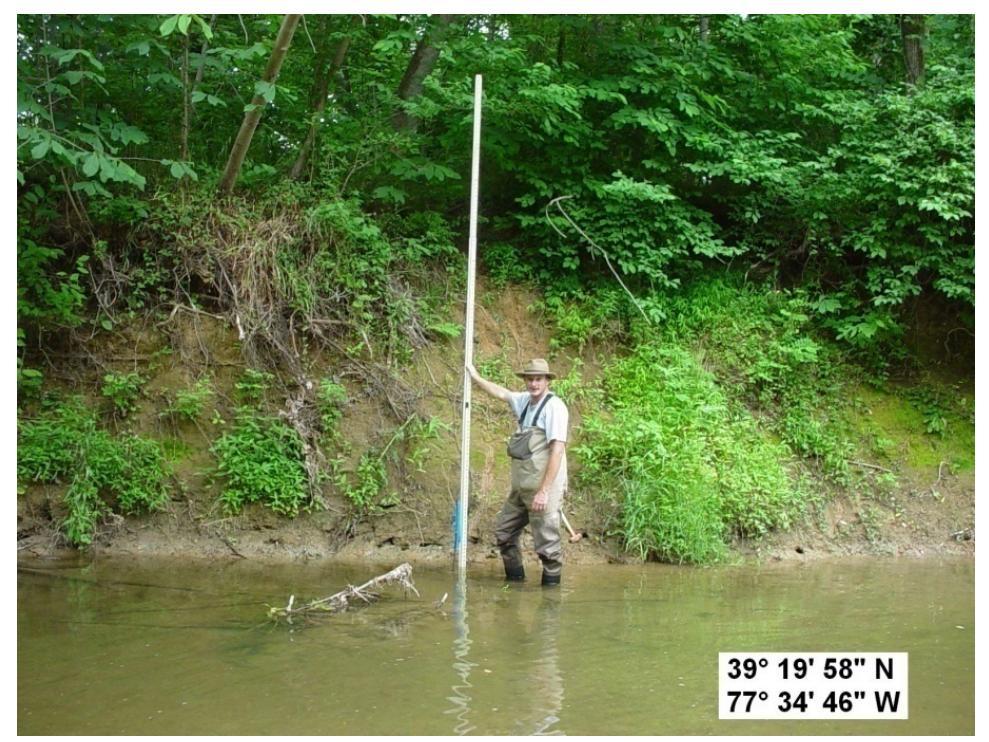
Photo 104: Vertical banks (10') composed fine laminated sediments.

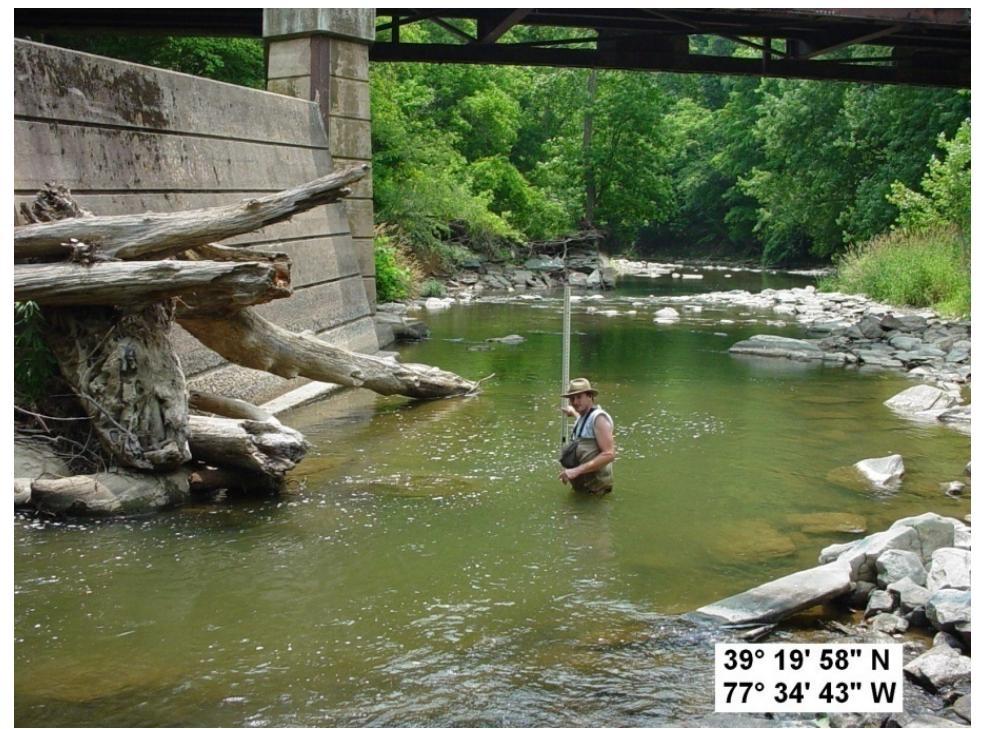
Photo 89: Looking downstream, scour hole at retaining wall above Pier D, pool depth 4'.

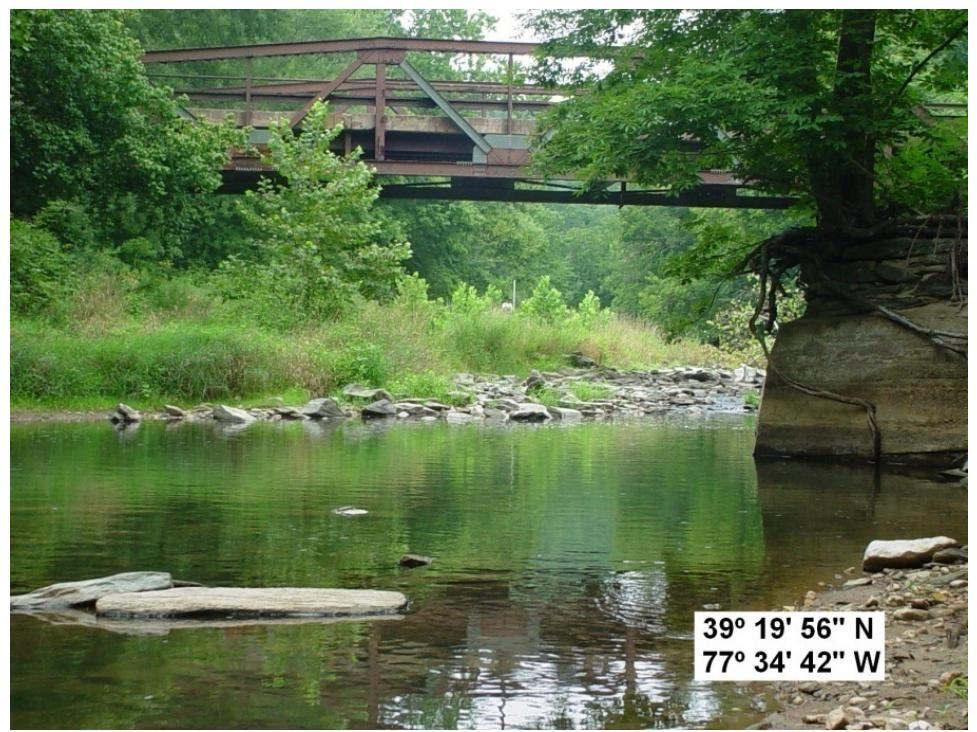
Photo 68: Looking upstream, deposition occurs throughout spans A-B, B-C, and C-D.

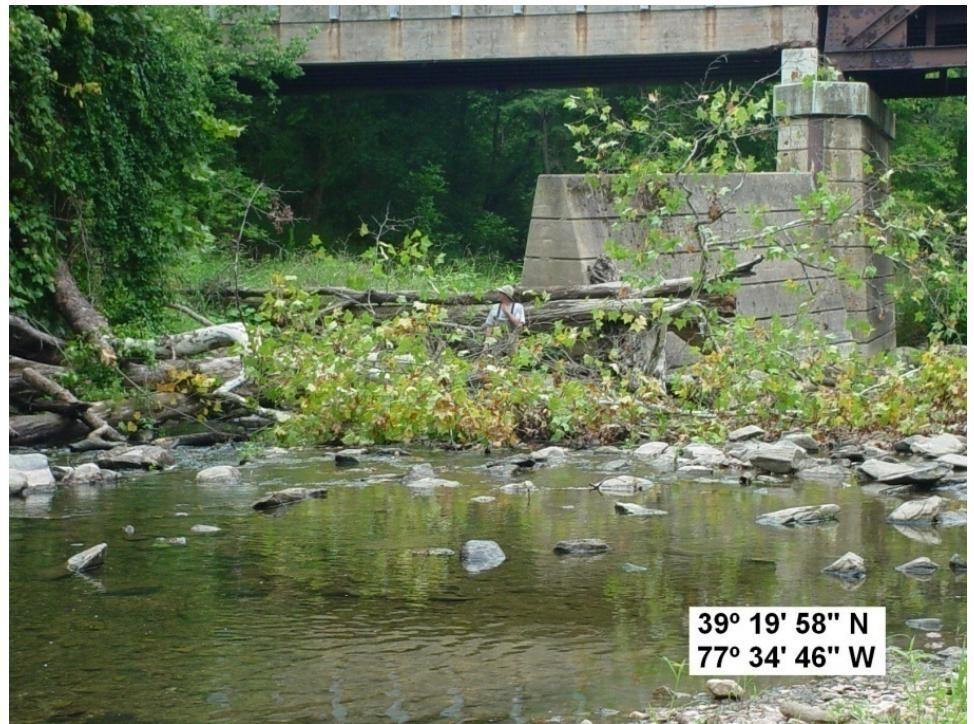
Photo 92: Debris collected at wall in front of Pier D.

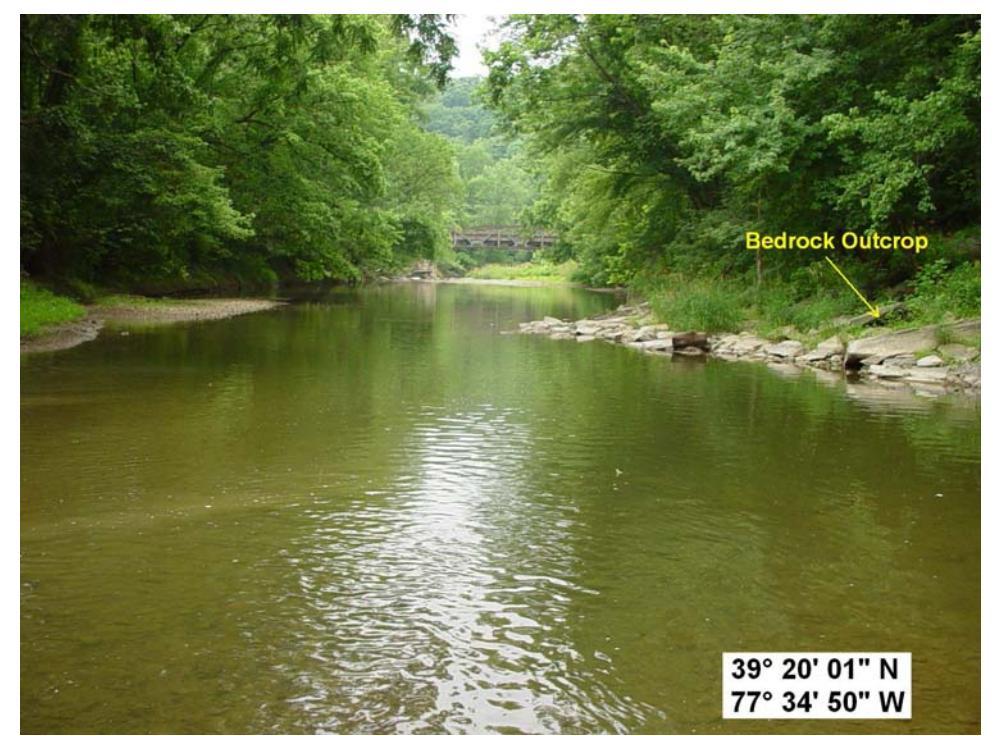
Photo 107: Approach flow direction and 10' high stream banks on either side. Note bedrock outcrop on right bank.

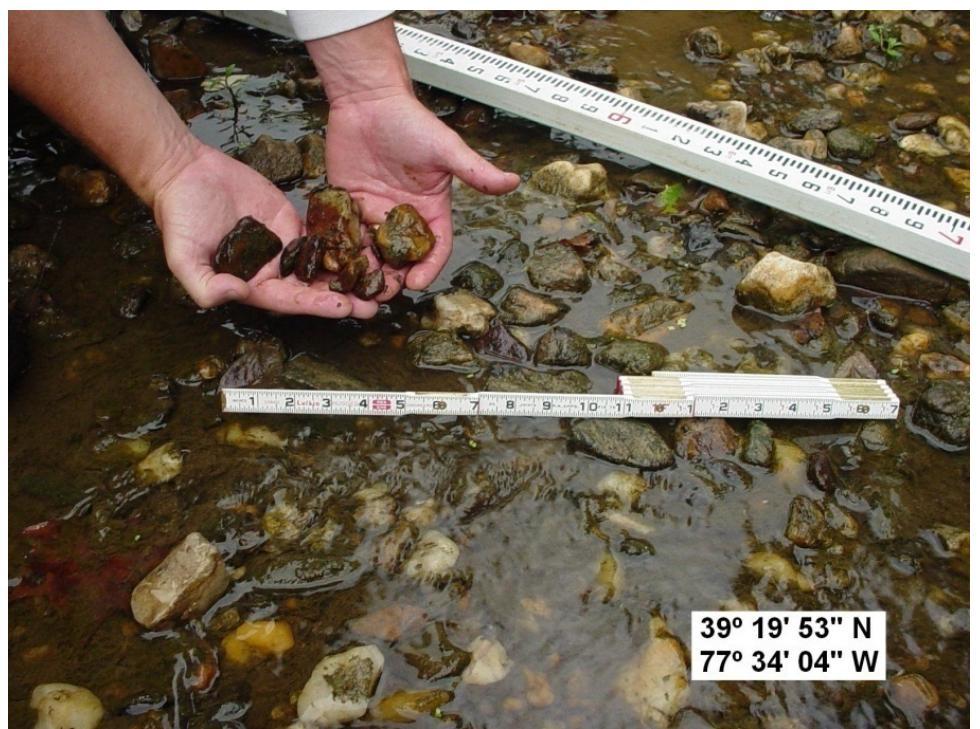
Photo 19: Quartz gravel forming LFHG feature.

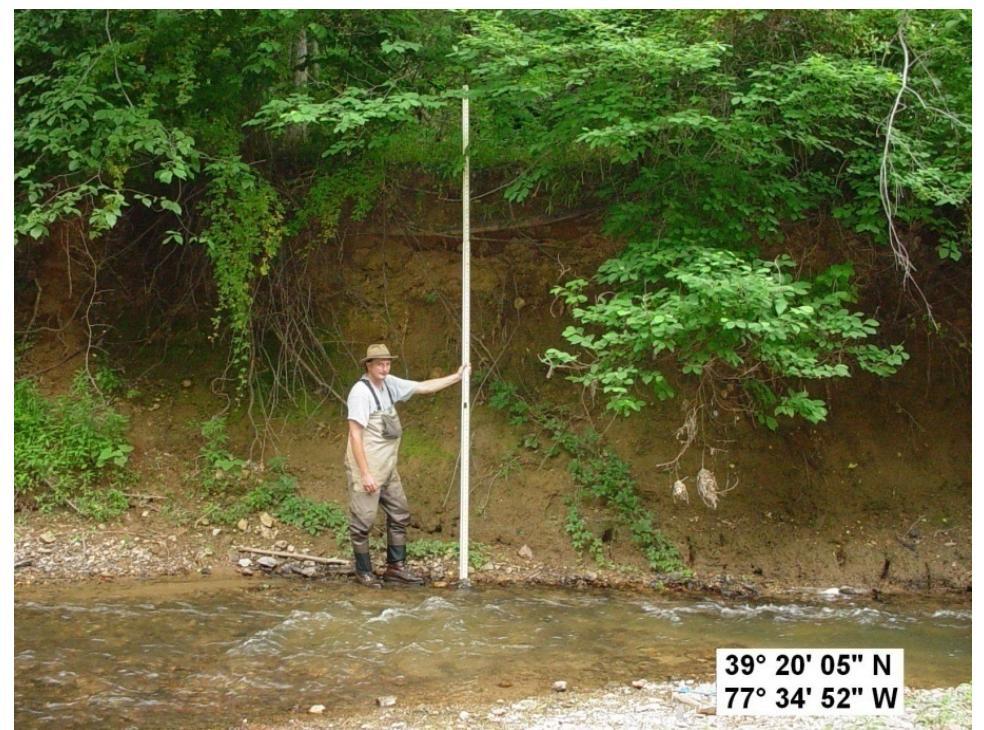
Photo 112: Left bank height 10'.
